Report of the

# PRESIDENTIAL COMMISSION

*on the Space Shuttle  
Challenger Accident*

June 6, 1986

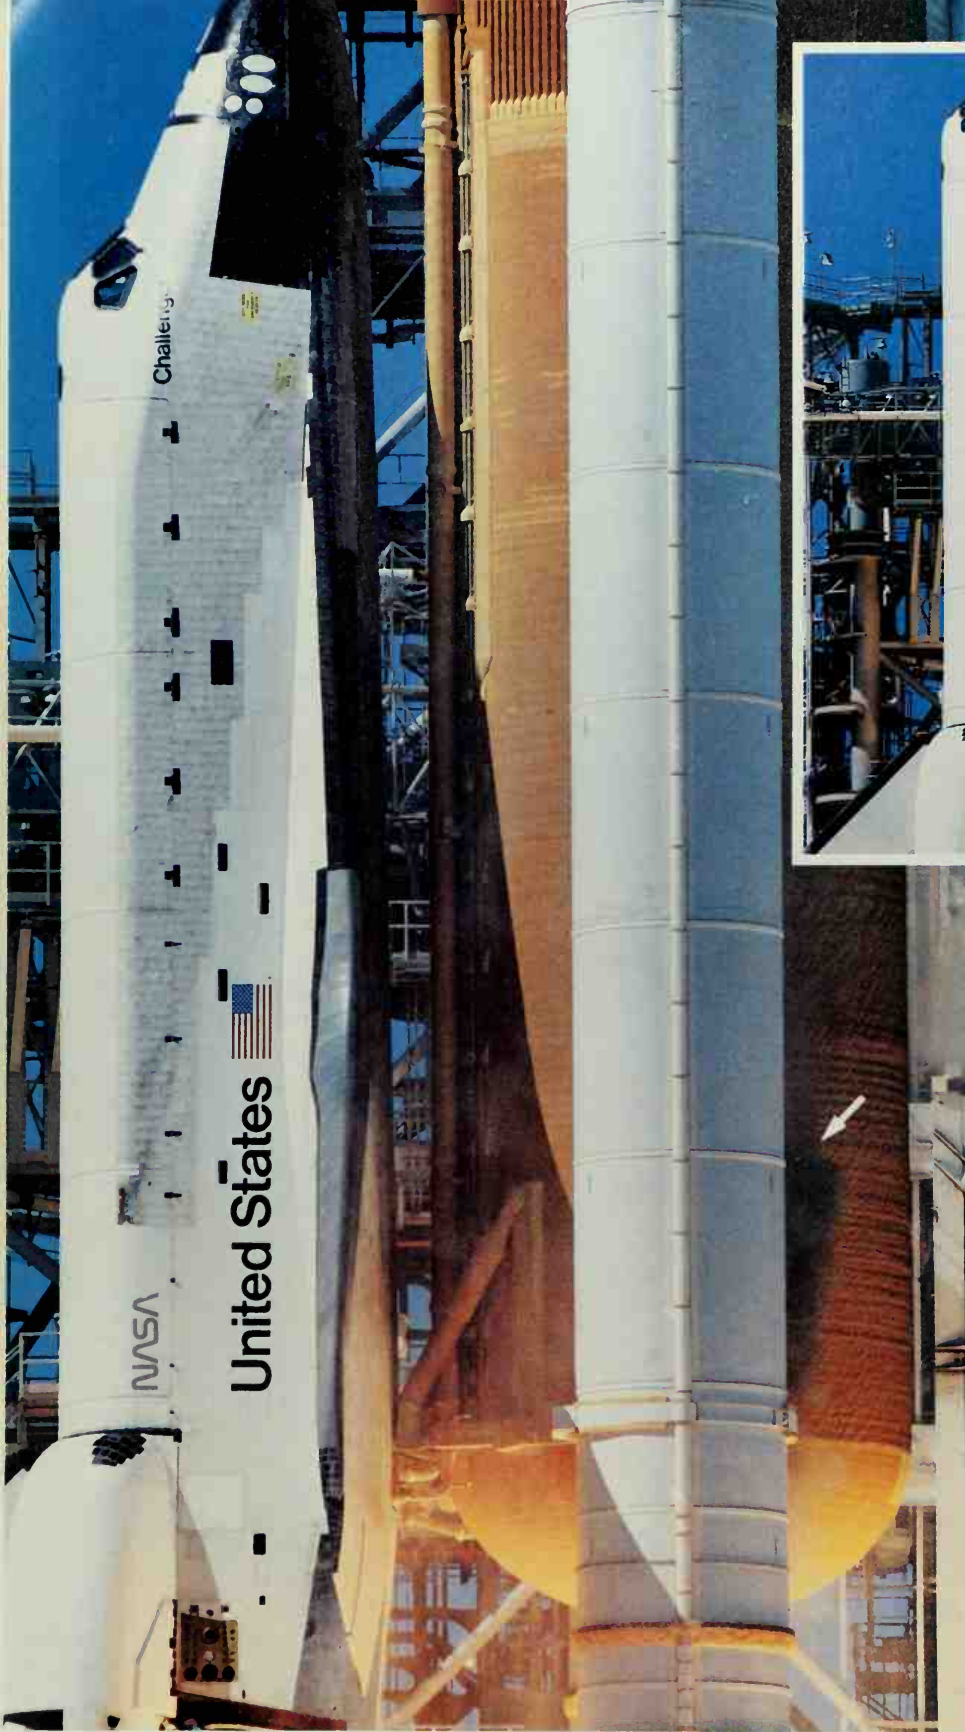
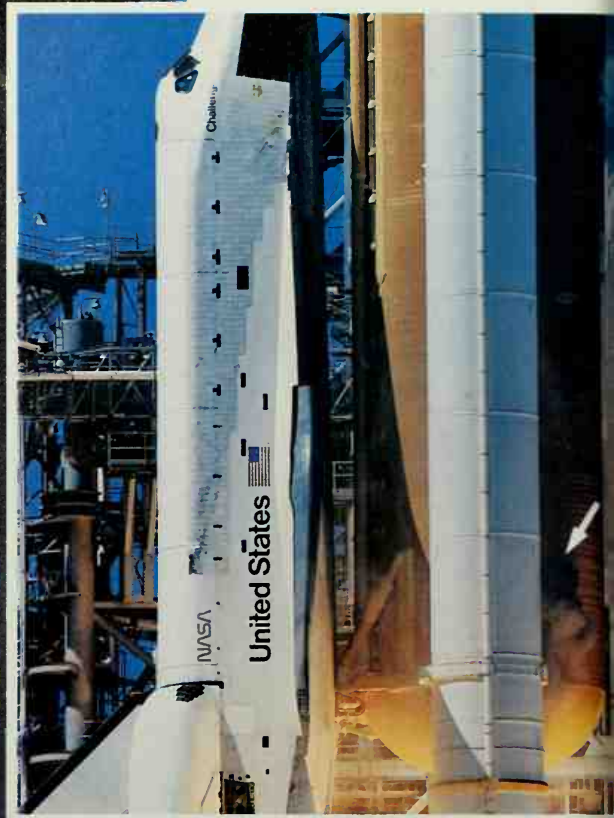
Immediately after solid rocket motor ignition, dark smoke (arrows) swirled out between the right hand booster and the External Tank. The smoke's origin, behavior and duration was approximated by visual analysis and computer enhancement of film from five camera locations. Consensus: smoke was first discernible at .678 seconds Mission Elapsed Time in the vicinity of the right booster's aft field joint.

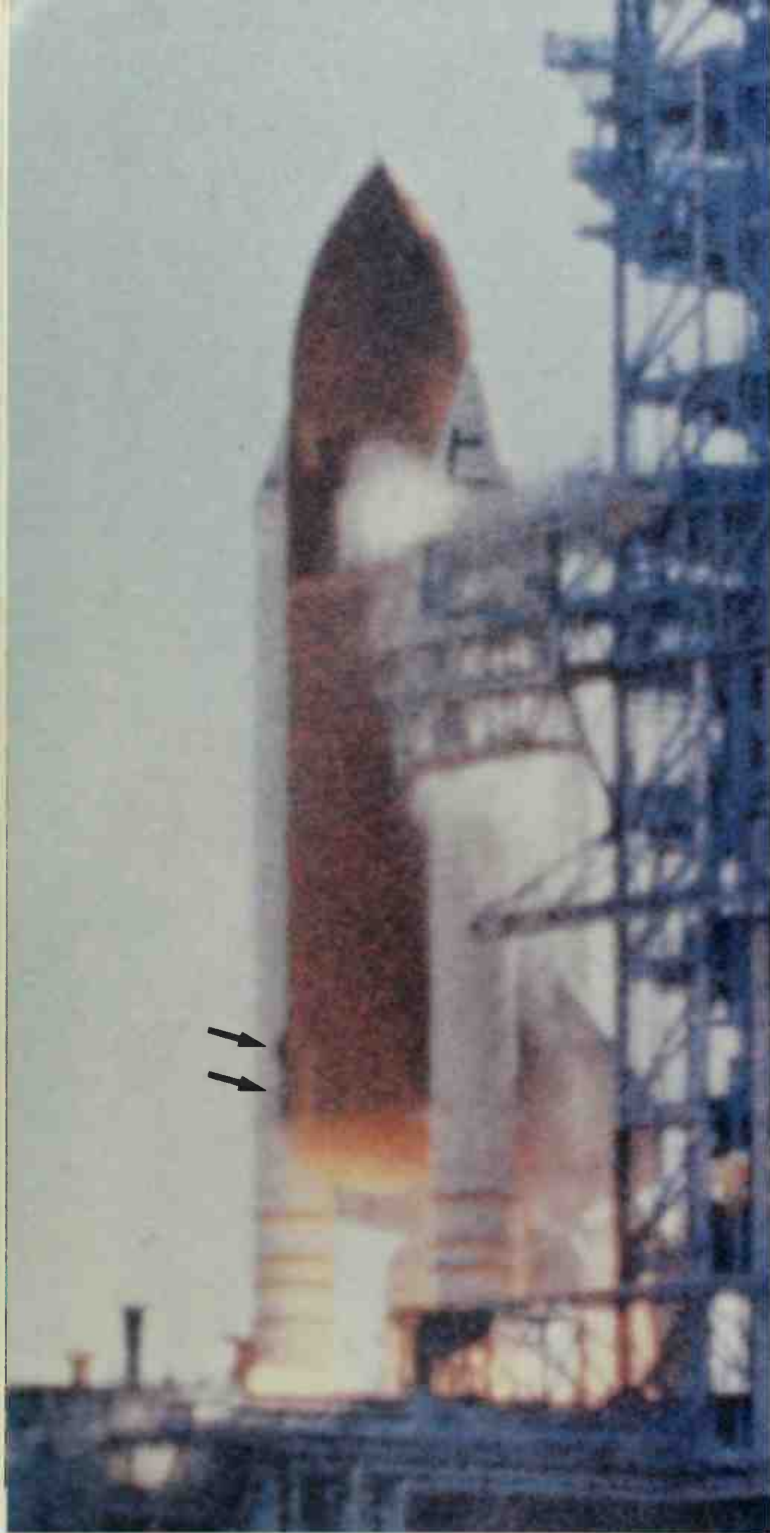
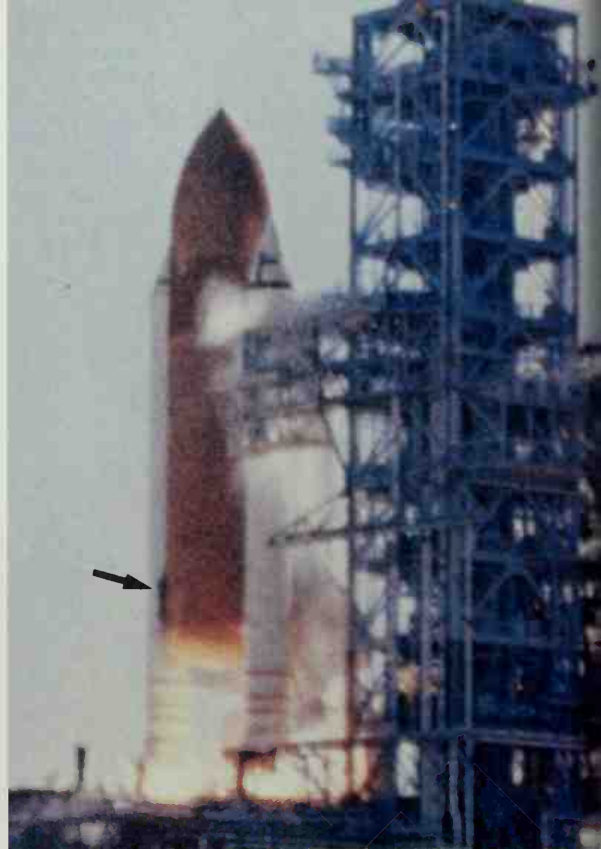
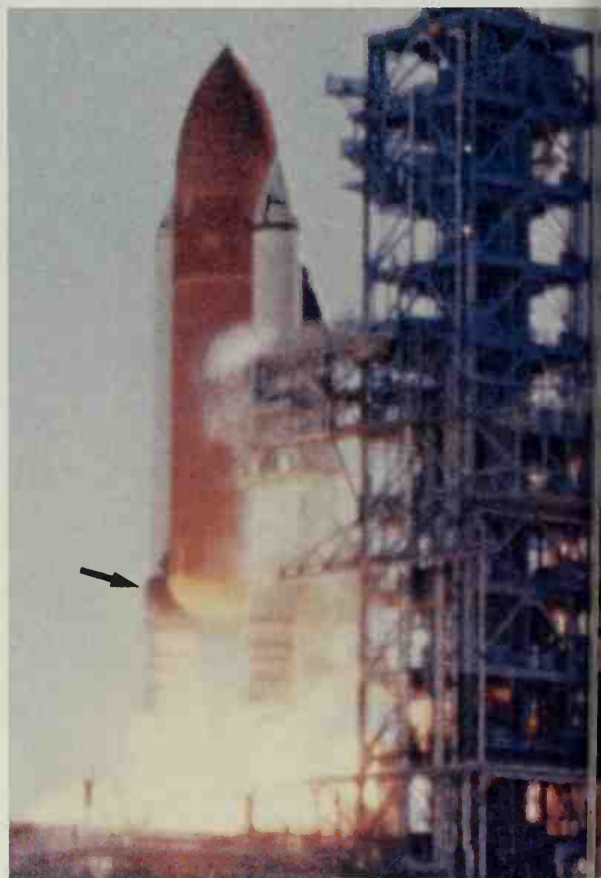
Multiple smoke puffs are visible in the photo above (arrows). They began at .836 seconds and continued through 2.500 seconds, occurring about 4 times a second. Upward motion of the vehicle caused the smoke to drift downward and blur into a single cloud. Smoke source is shown in the computer generated drawing (far right).

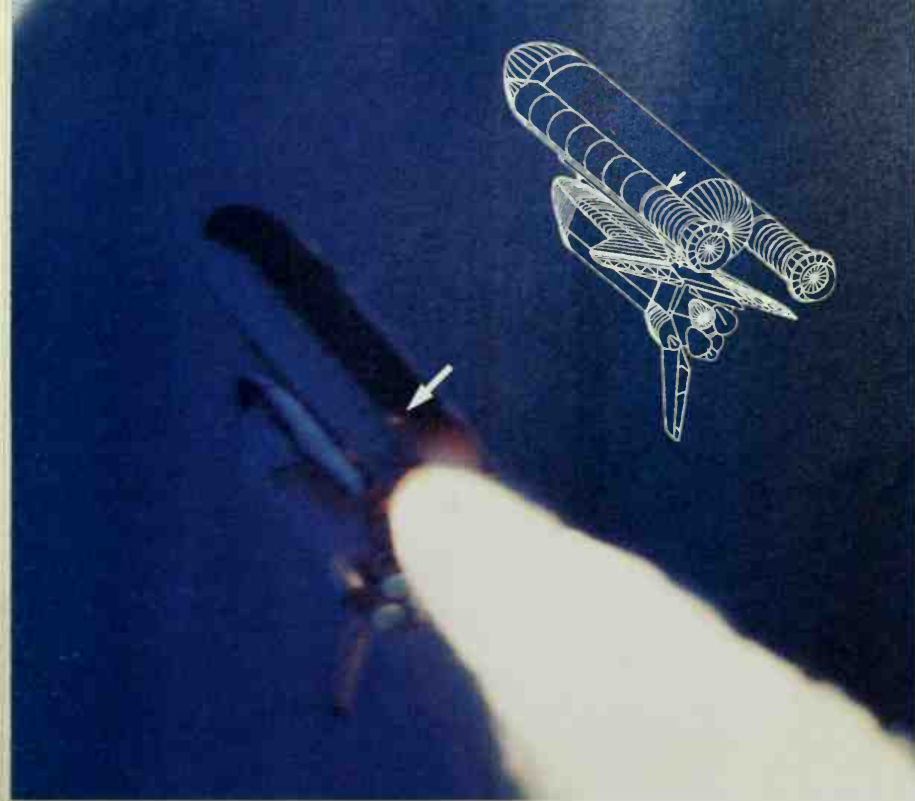
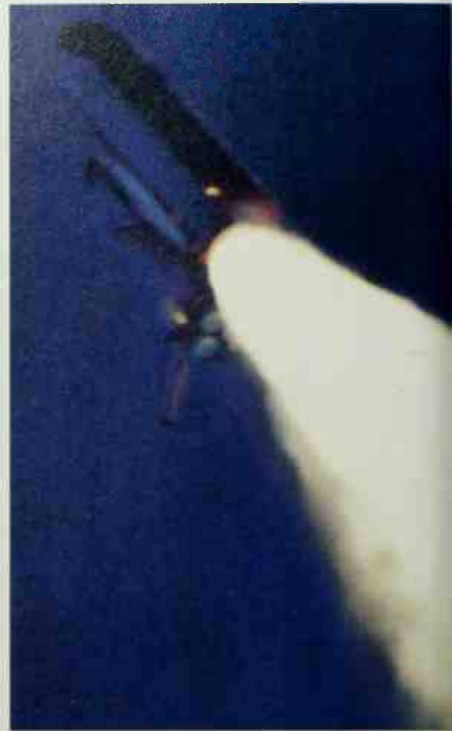
At 58.788 seconds, the first flicker of flame appeared. Barely visible above, it grew into a large plume and began to impinge on the External Tank at about 60 seconds. Flame is pinpointed in the computer drawing between the right booster and the tank, as in the case of earlier smoke puffs. At far right (arrow), vapor is seen escaping from the apparently breached External Tank.

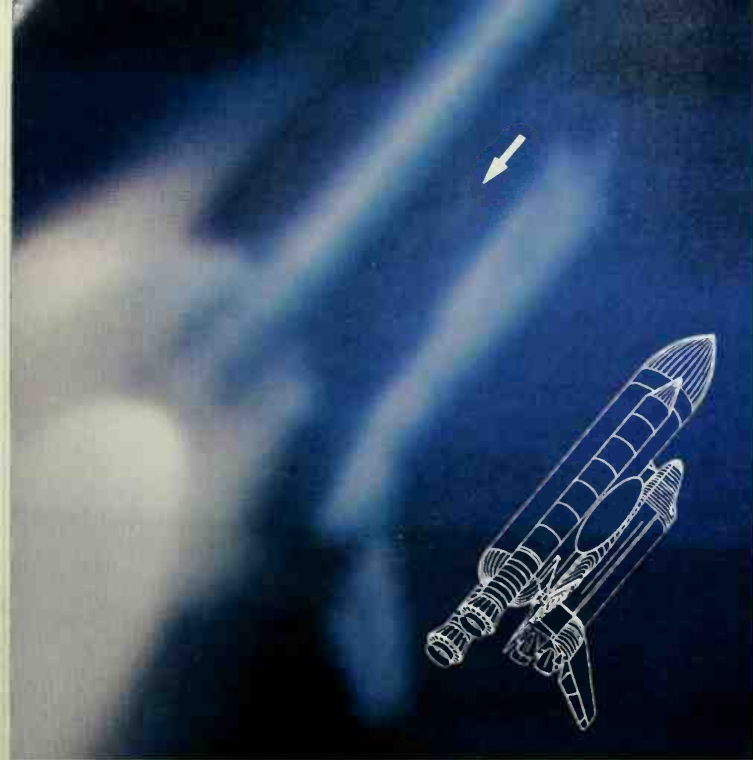
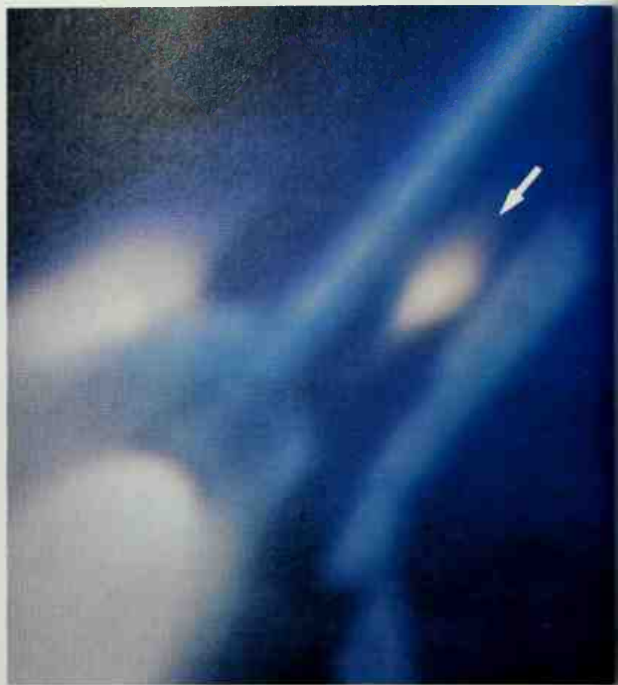
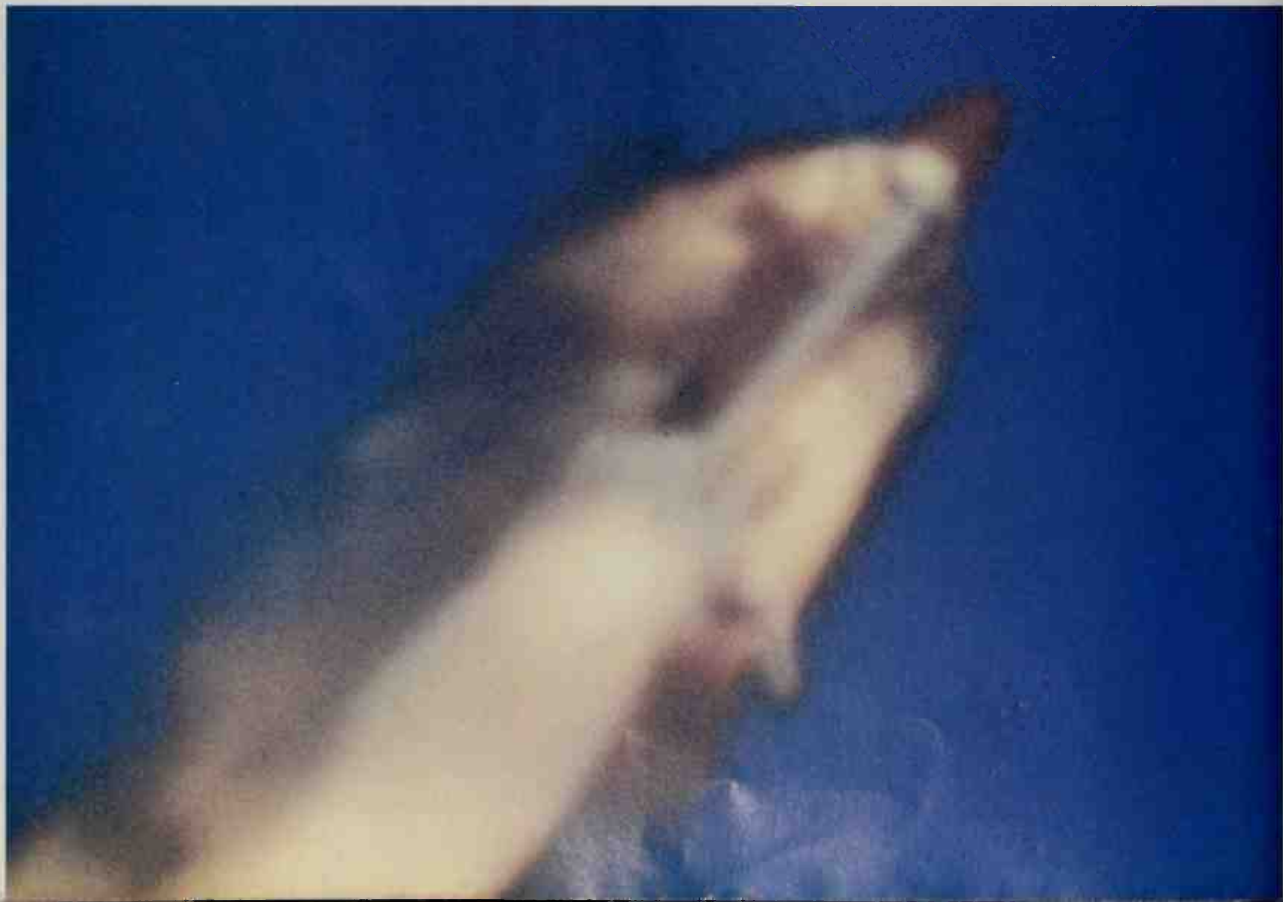
Camera views indicate the beginning of rupture of the liquid hydrogen and liquid oxygen tanks within the External Tank. A small flash (arrows above) intensified rapidly, then diminished. A second flash,

attributed to rupture of the liquid oxygen tank, occurred above the booster/tank forward attachment (below left) and grew in milliseconds to the maximum size indicated in the computer drawing.

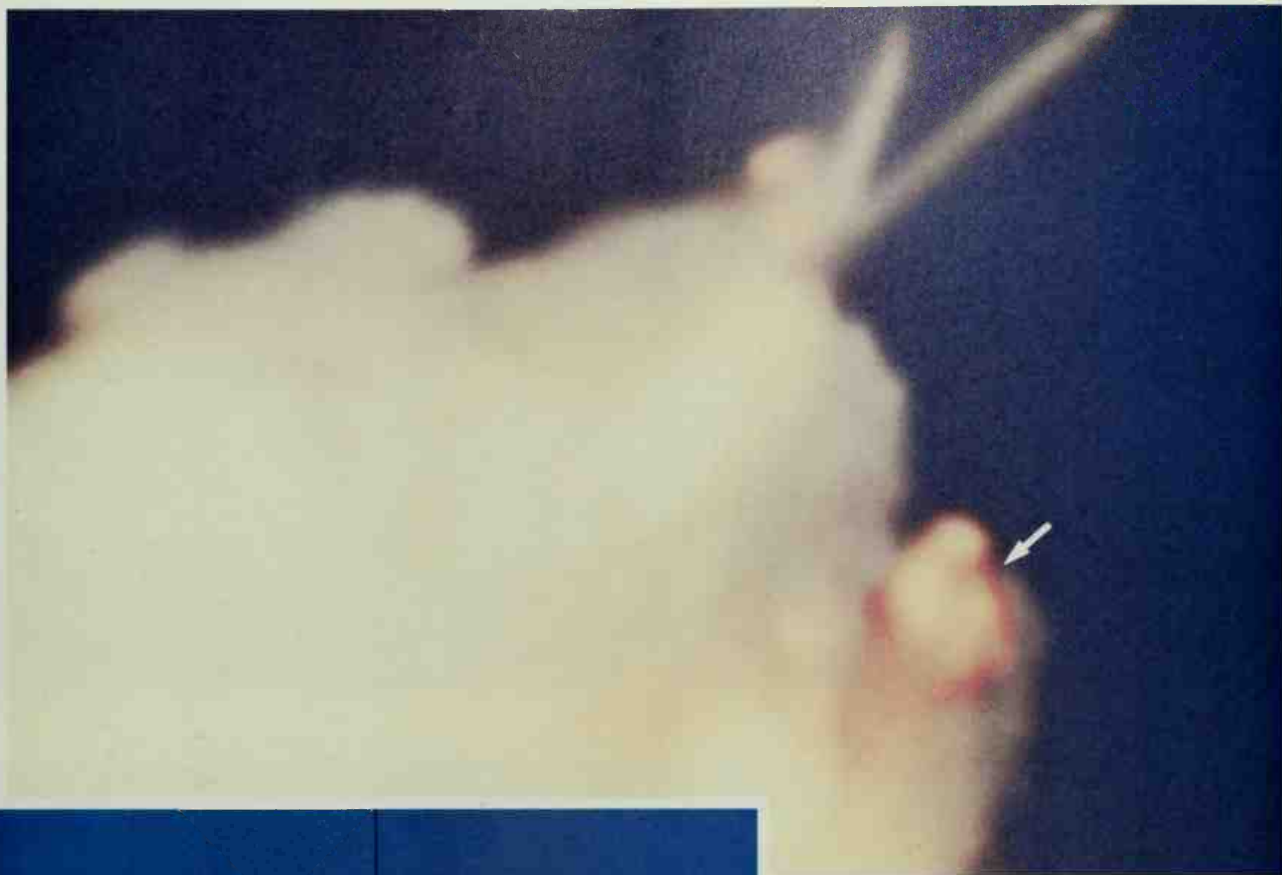
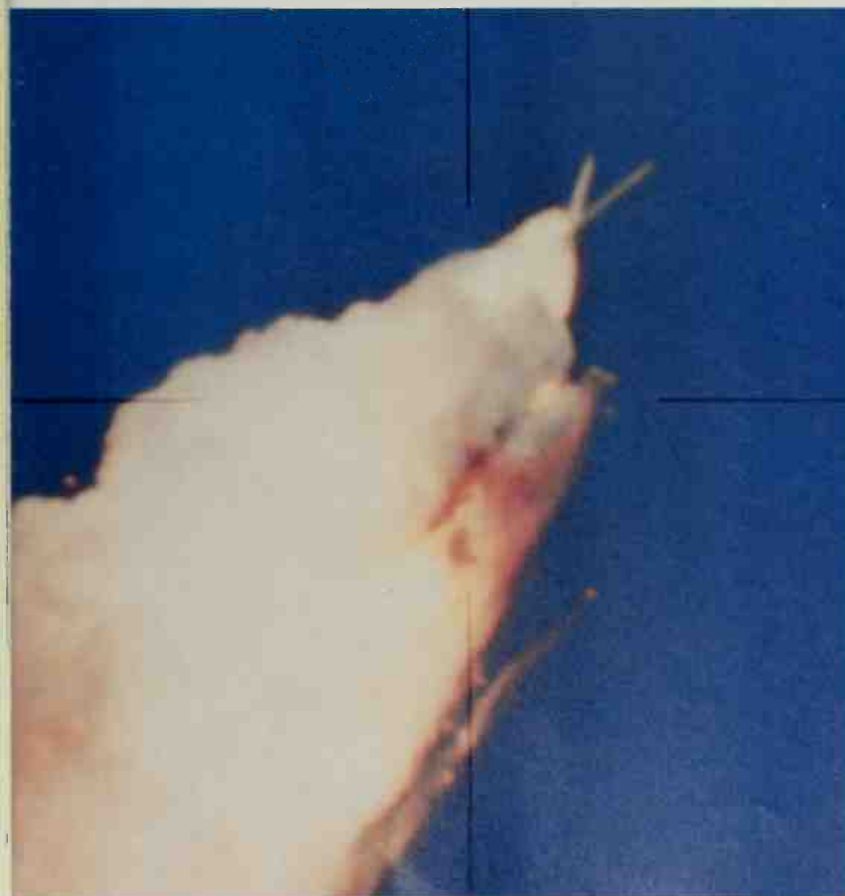
Structural breakup of the vehicle began at approximately 73 seconds. Fire spread very rapidly. Above, a bright flash (arrow) is evident near the nose of the Orbiter, suggesting spillage and ignition of the spacecraft's reaction control system propellants. At left, the two Solid Rocket Boosters thrust away from the fire, crisscrossing to form a "V." The right booster—identifiable by its failure plume—now to the left of its counterpart. At right, the boosters diverge farther; the External Tank wreckage is obscured by smoke and vapor. The Orbiter engines still firing, is visible at bottom center.

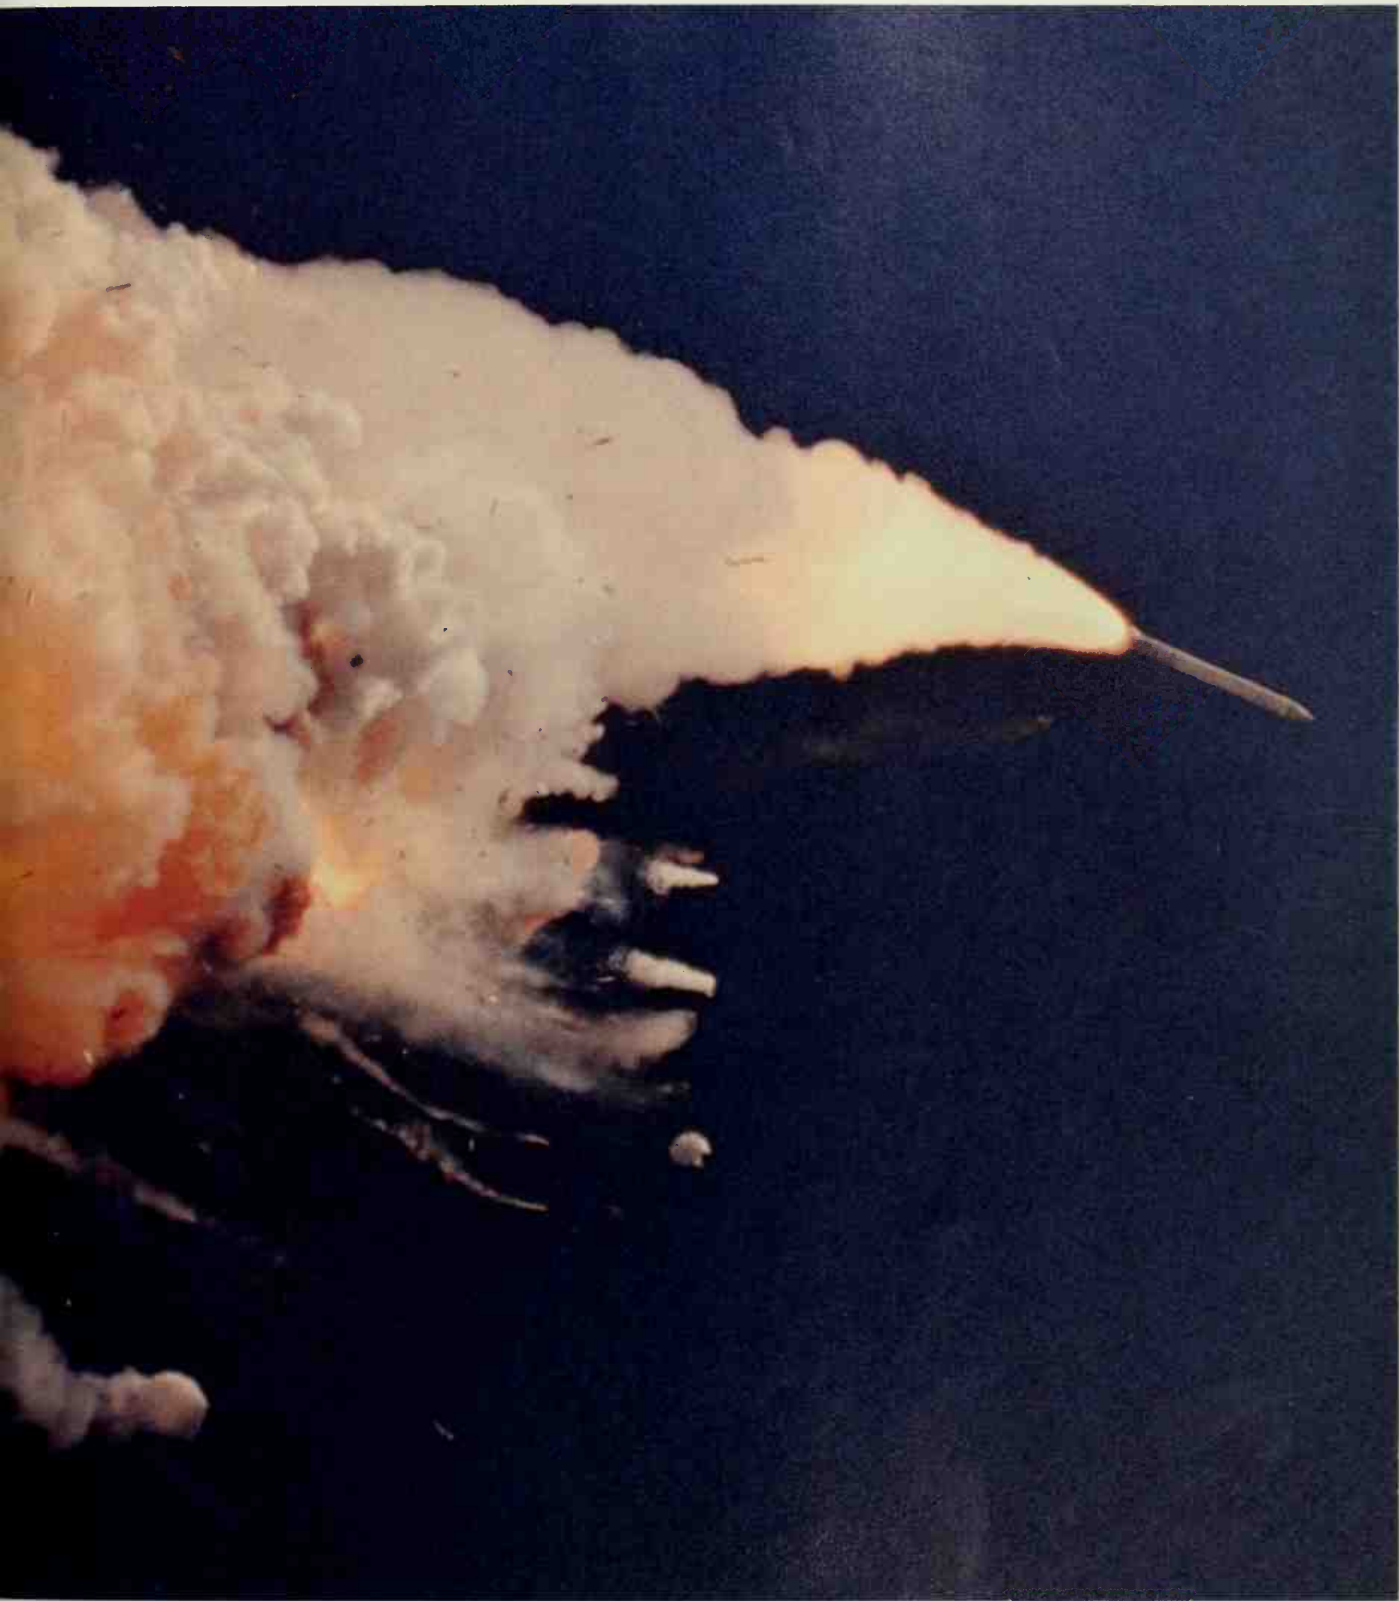
At about 76 seconds, unidentifiable fragments of the Shuttle vehicle can be seen tumbling against a background of fire, smoke and vaporized propellants from the External Tank (left). In the photo at right, the left booster (far right)

soars away, still thrusting. The reddish-brown cloud envelops the disintegrating Orbiter. The color is characteristic of the nitrogen tetroxide oxidizer in the Orbiter Reaction Control System propellant.

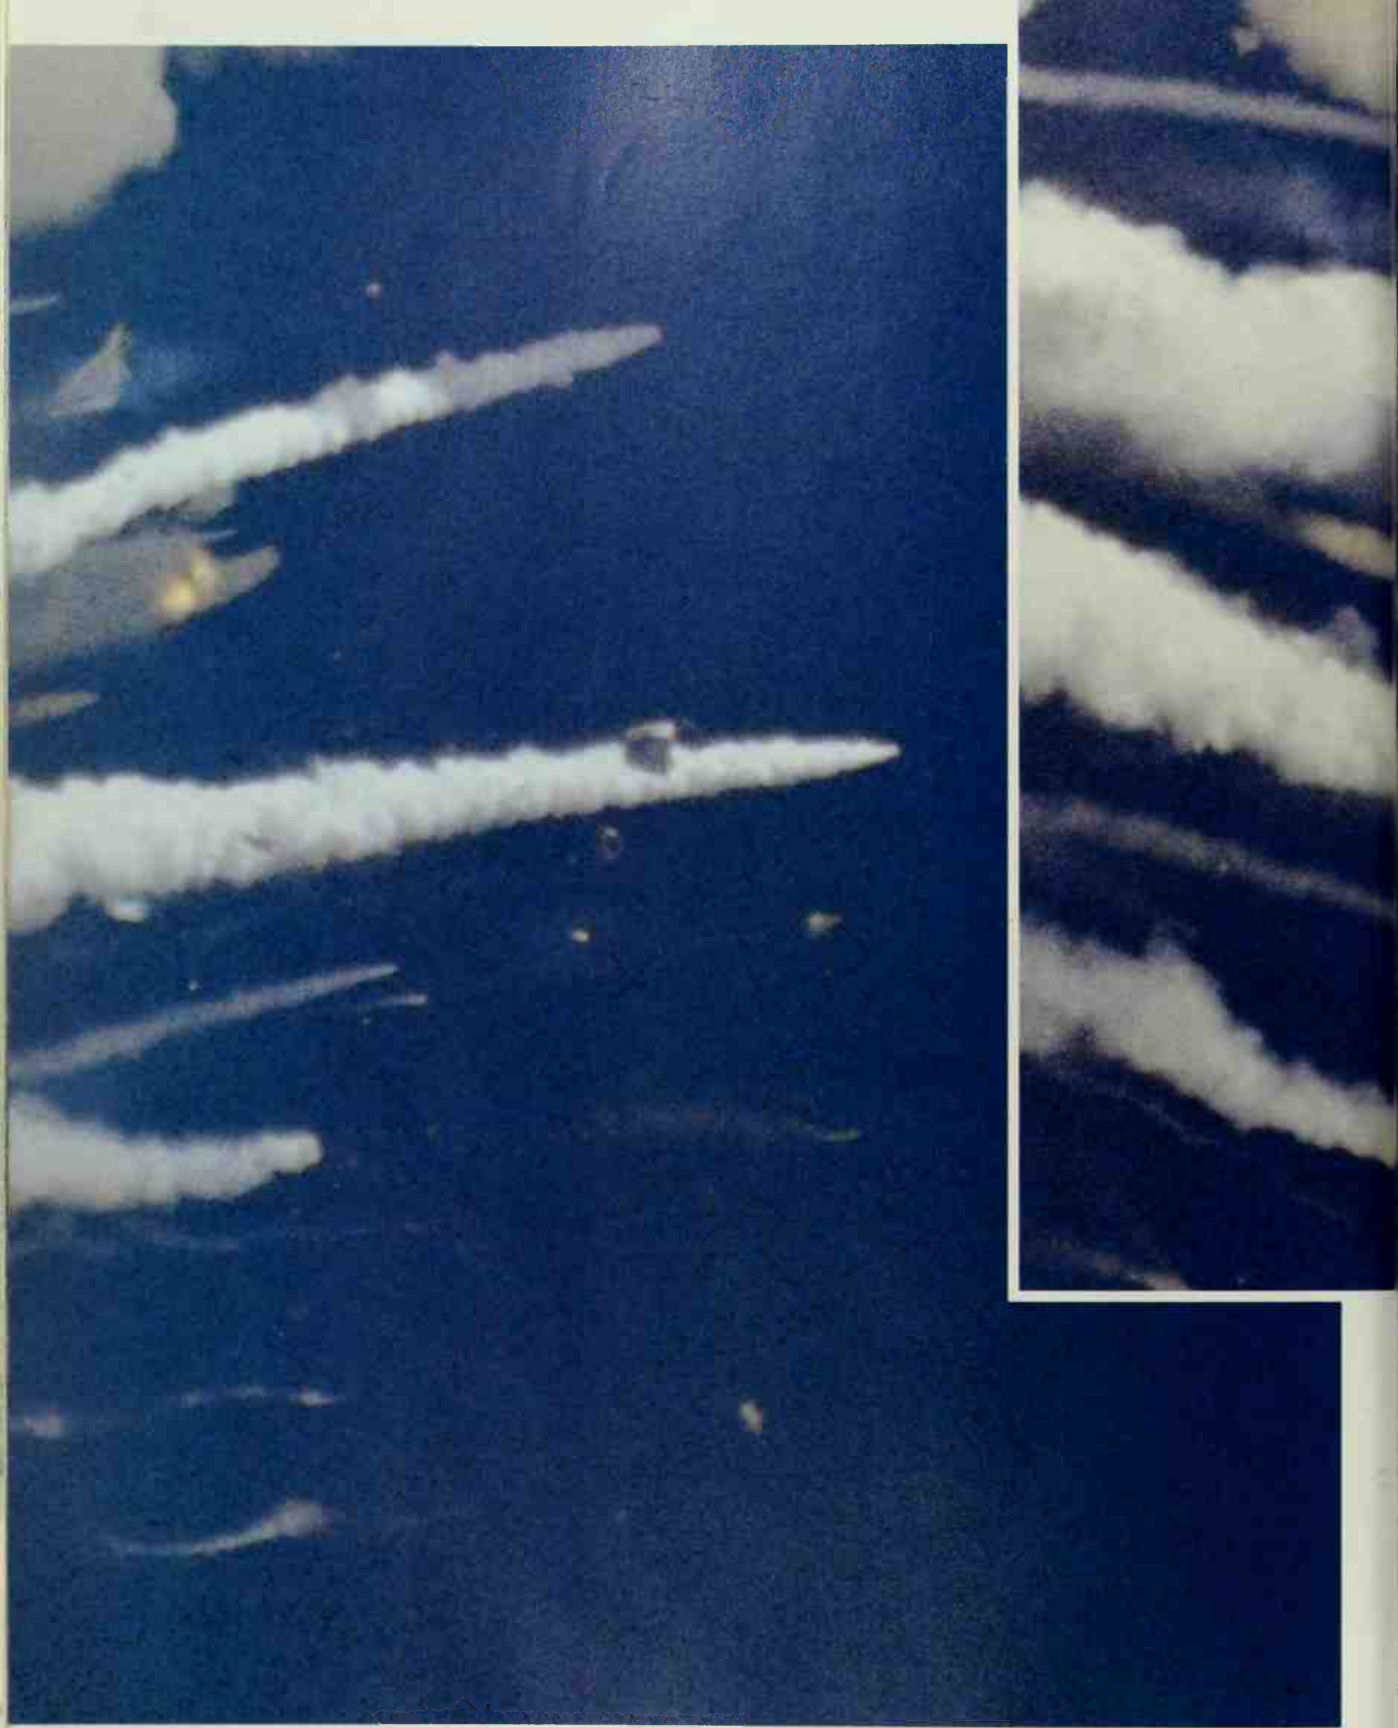
Hurling out of the fireball at 78 seconds (left) are the Orbiter's left wing (top arrow), the main engines (center arrow) and the forward fuselage (bottom arrow). In the photo below, it plunges Earthward, trailed by smoking fragments of Challenger.

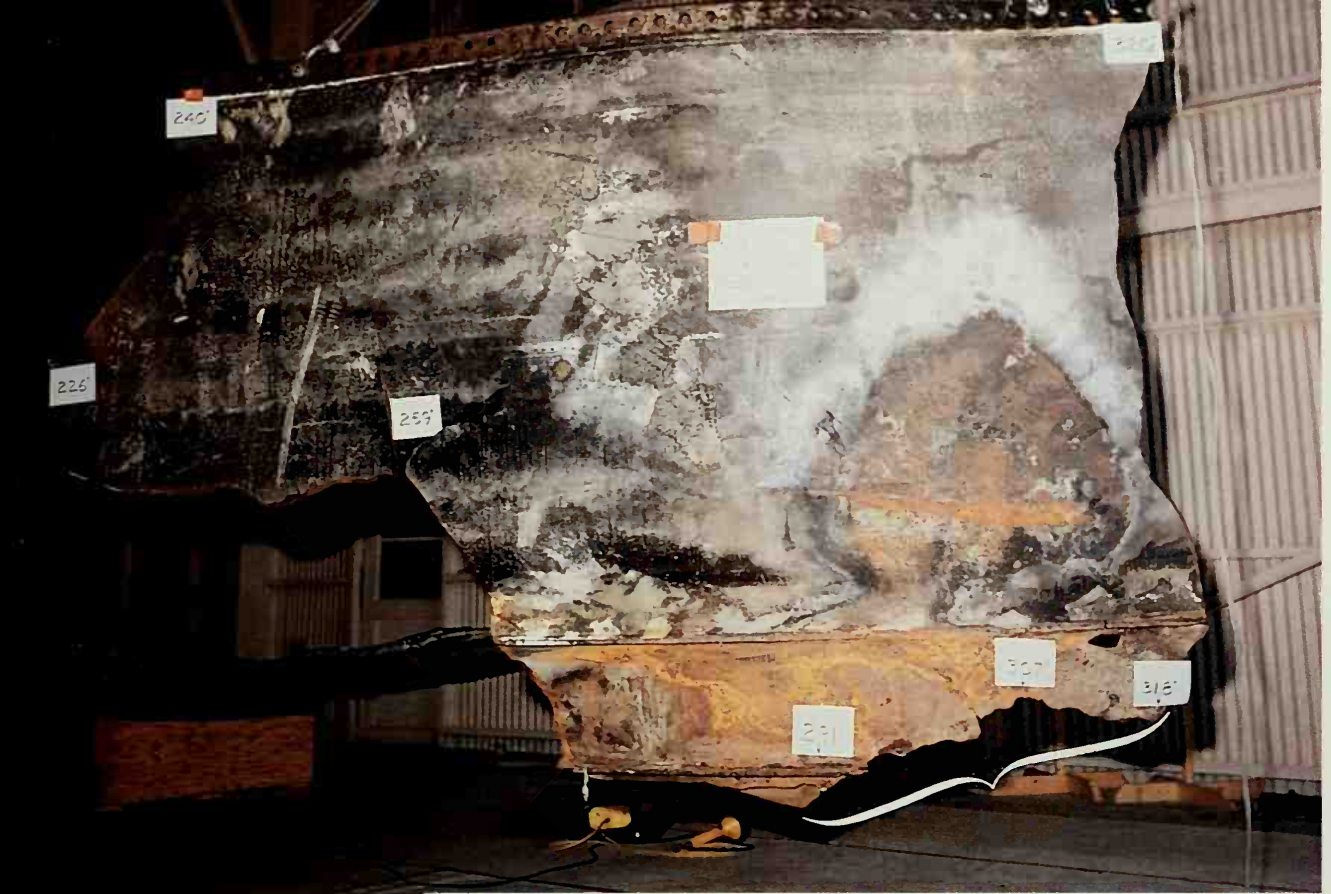
L

Examined at Kennedy Space Center after their recovery from the ocean, these fragments show the extent of burn through the right hand booster's aft field joint. On the left page are sections of the aft center motor segment above the joint. On the right page are sections (inverted) of the aft motor segment showing burn-hole below the joint (bracket). Except for the interior views on lower left, the camera is viewing the parts from outside the casing.

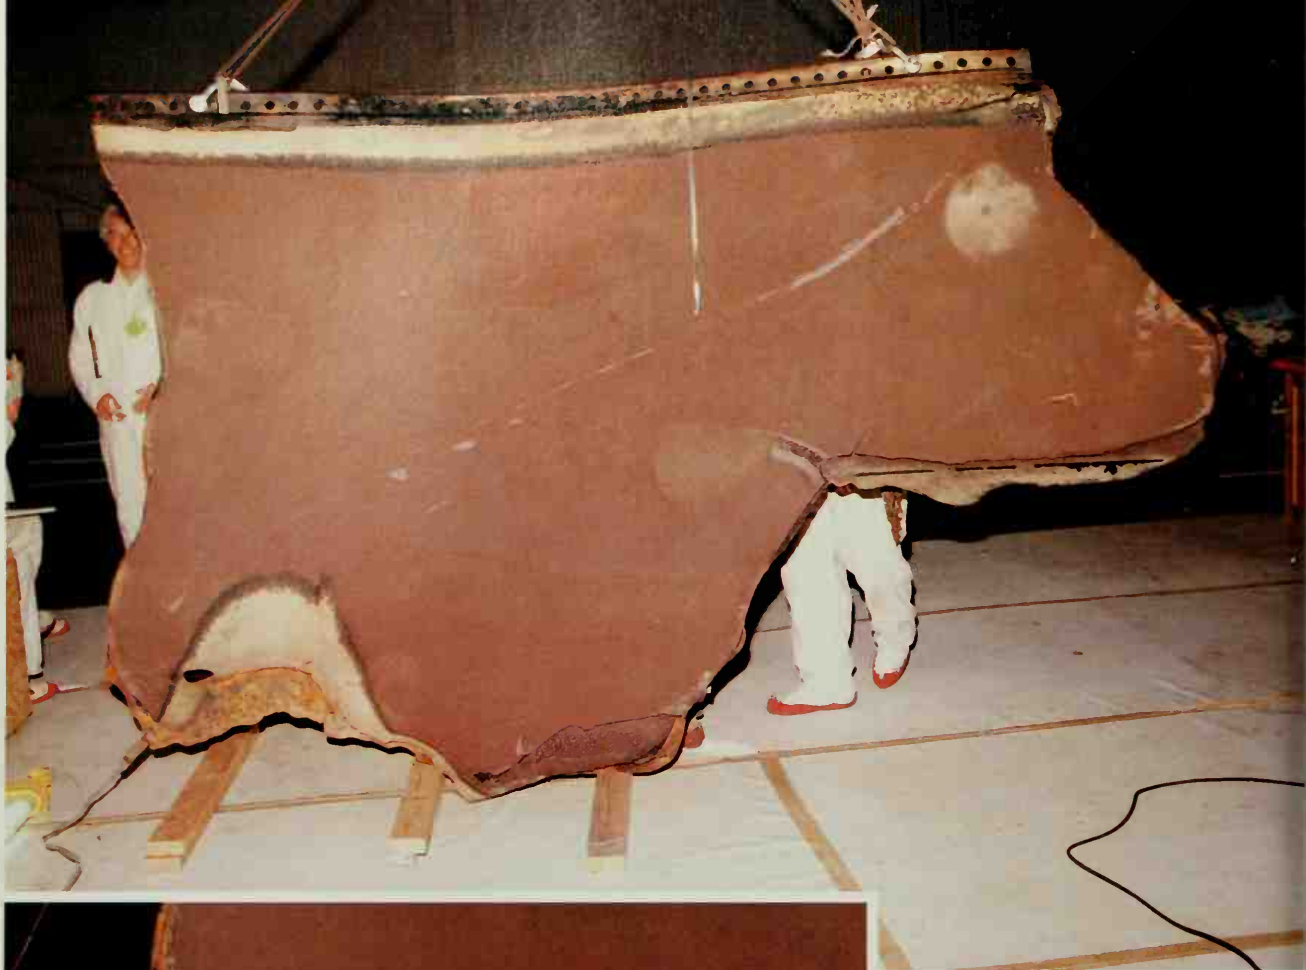
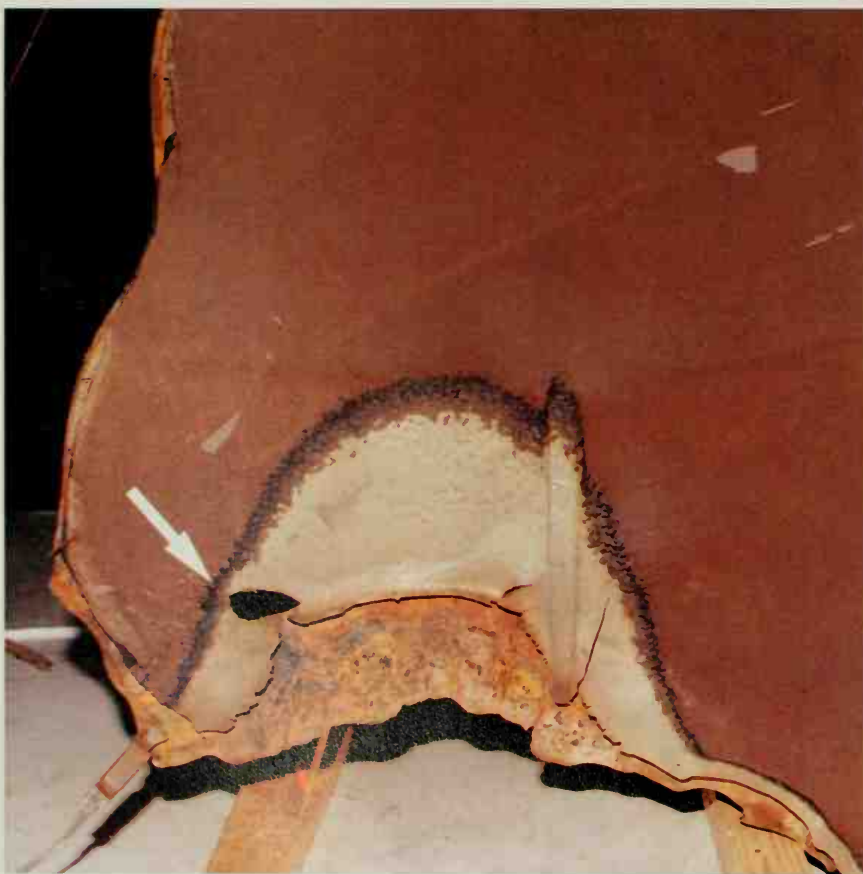
At upper left is the aft segment burn viewed from inside the casing; the lower photo is a closeup of the same section. The latter photo shows a hole (arrow) where the flame plume may have burned through the casing from the outside. At right is a composite view of the burn above and below the aft field joint.

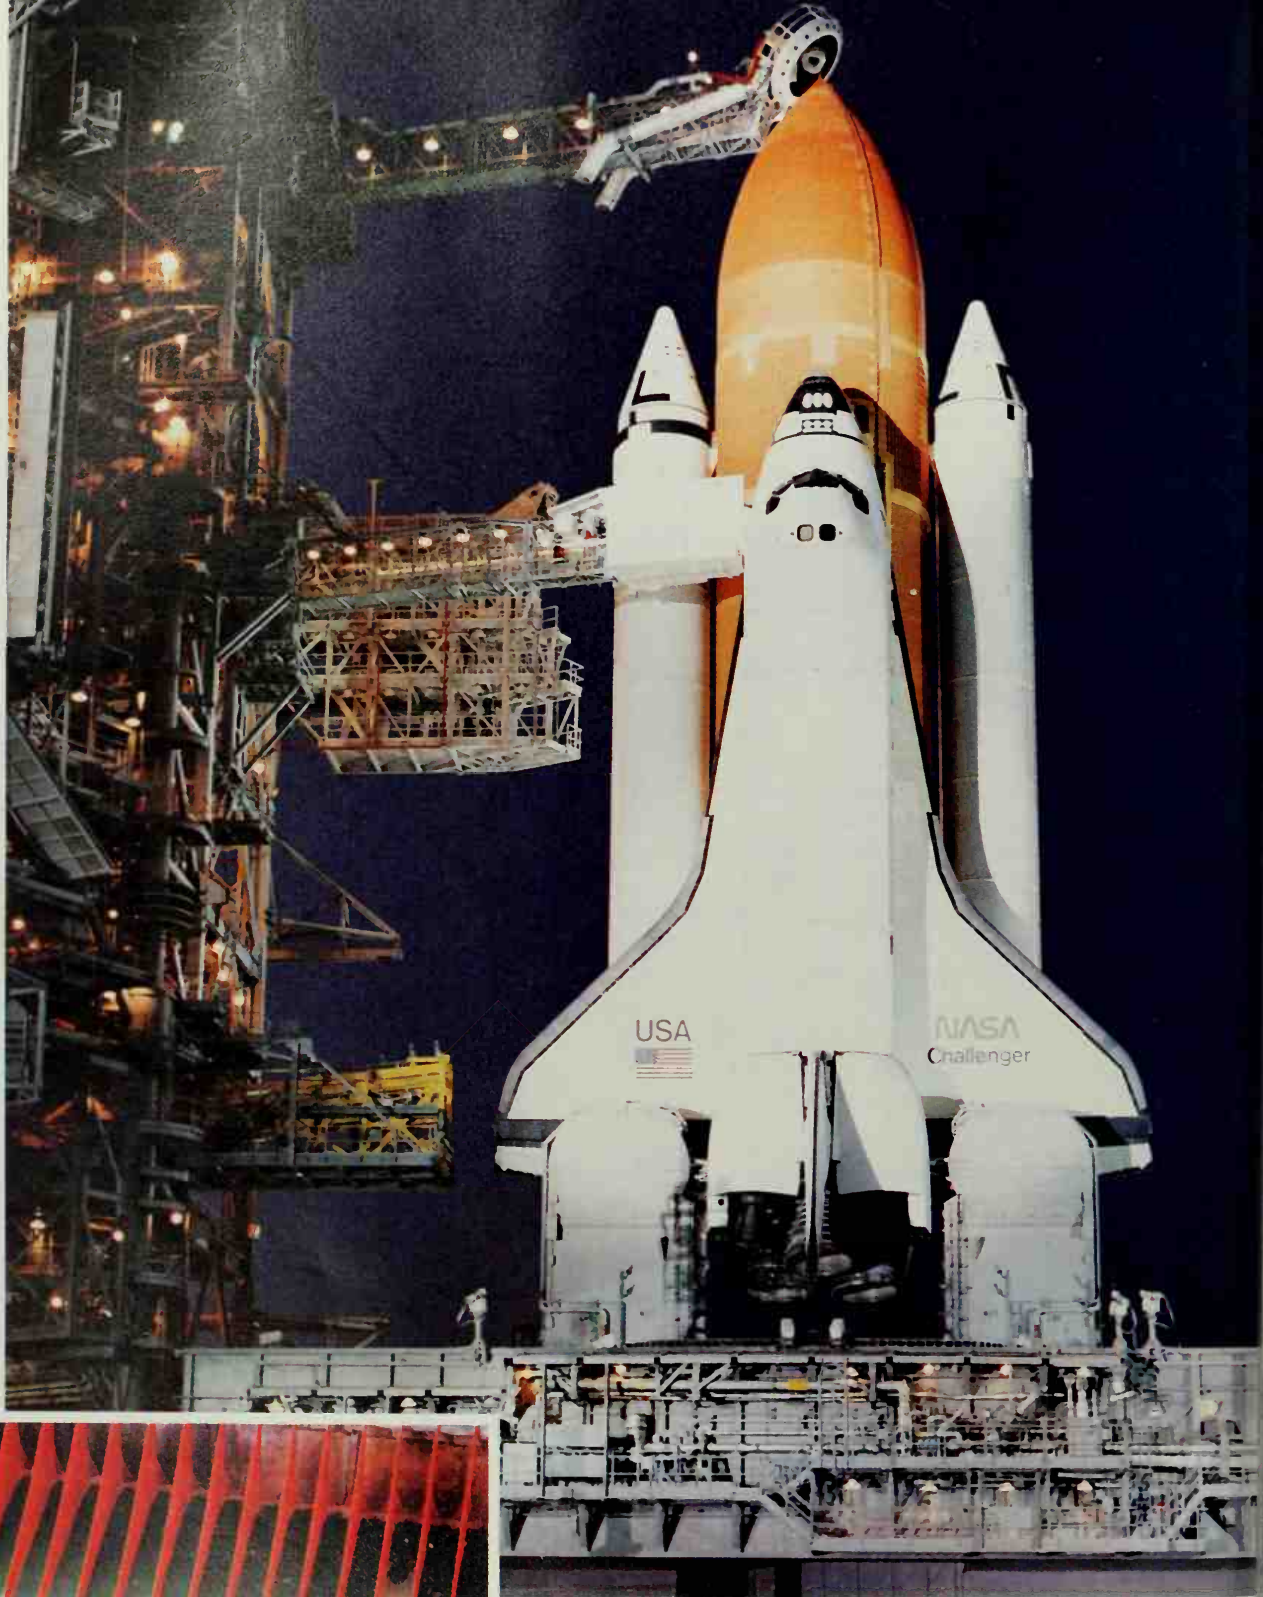
Above, Shuttle 51-L on Kennedy Space Center Pad 39B in the early morning of launch day. Temperatures were well below freezing, as indicated by the lower left photo, which shows thick ice in a water trough despite use of an anti-freeze solution.

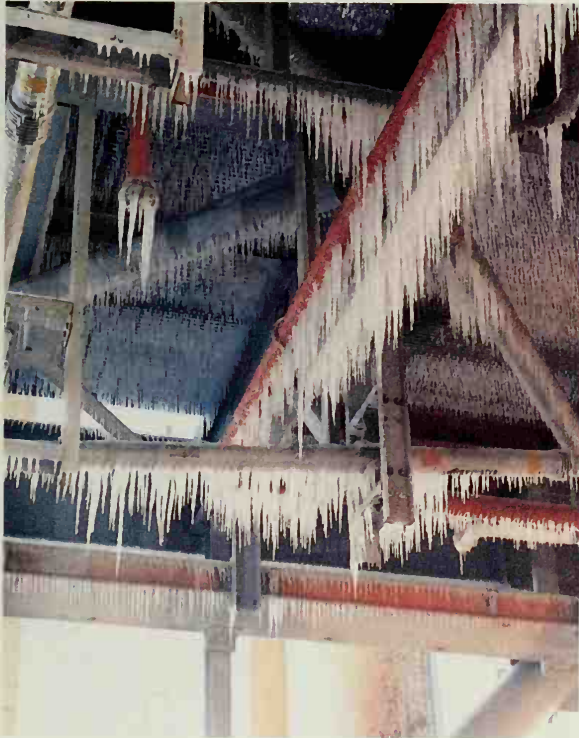
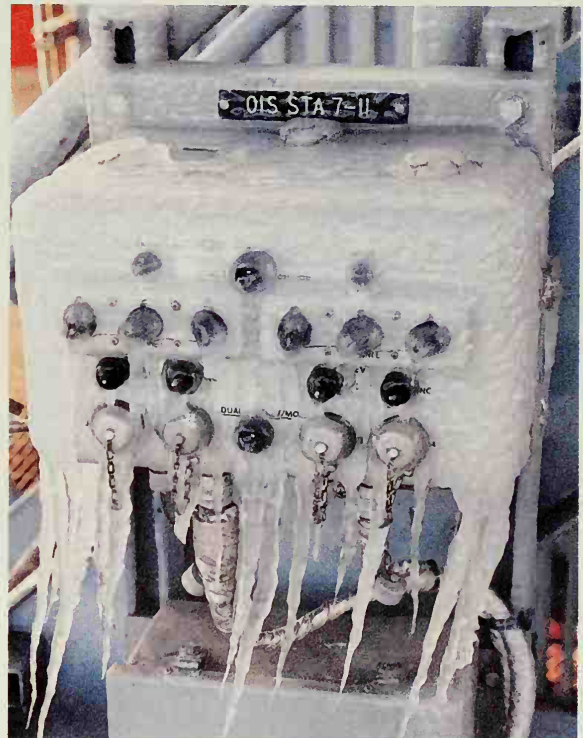
Above, foot long icicles on a lower level of the Fixed Service Structure frame the attachment point where the Orbiter is attached to the external tank (arrow). Icing was even more extensive at upper levels of the service structure (upper right and below). At right below is a ground communications box (not used during launch) rendered inoperable by heavy ice.

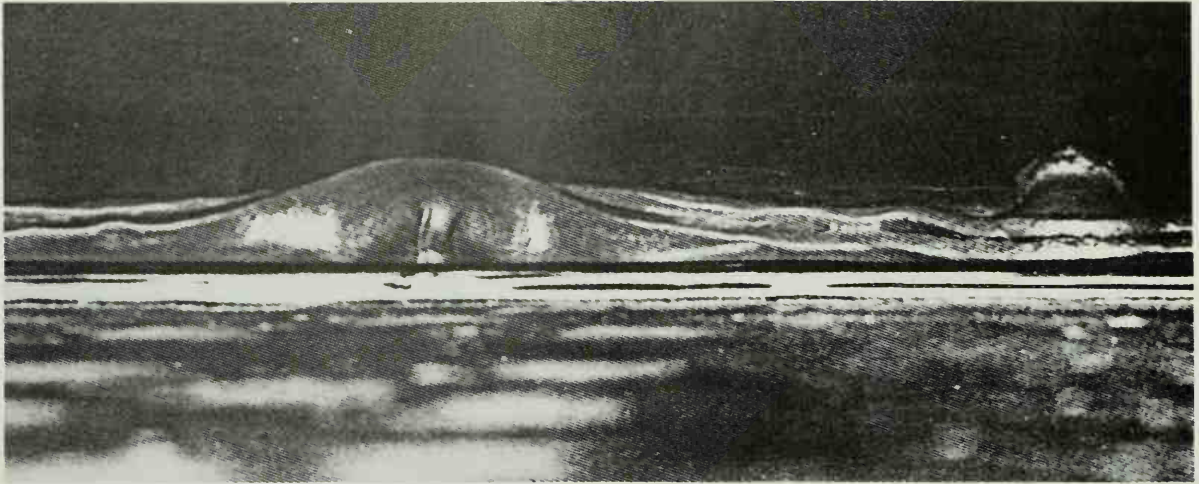
Pressure tests at 200 pounds per square inch of the Solid Rocket Booster joints produced bubbles in putty used to line the joints.
